SMC-TR-94-02

AEROSPACE REPORT NO. TR-93(3904)-1

Honeycomb Sandwich Structures: Vented Versus Unvented Designs for Space Systems

October 1993

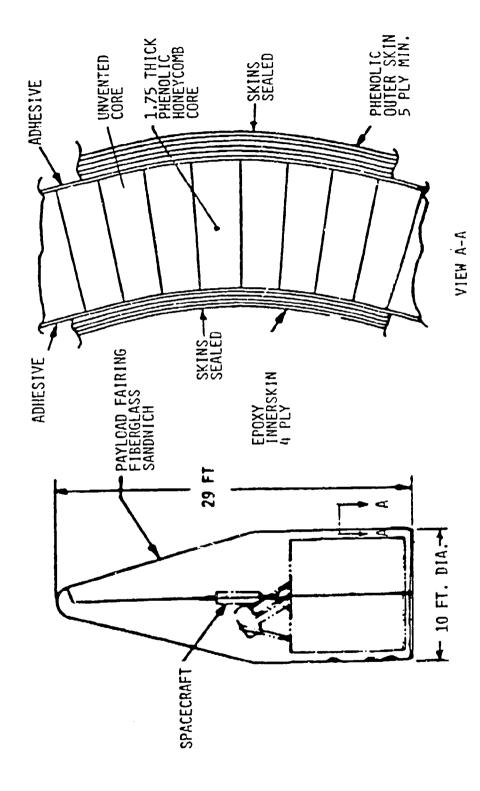
Figure 2. Fiberglass Payload Fairing

Figure 2 (from Ref. 2) shows the construction, consisting of a four-ply glass/epoxy inner skin and a five-ply glass/phenolic outer skin, bonded with HT-424 film (tape) adhesive to 1.75-in. thick HRP (glass/phenolic) honeycomb core of 3/8 in. cell size.

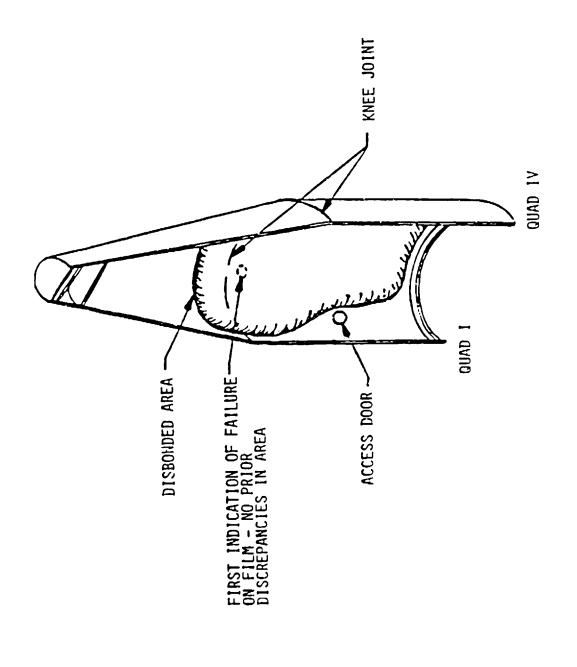
Figure 3. Spare Payload Fairing Uncapped Half Inner Skin Debond

During the proof test of the AC-58 payload fairing, it exploded. High-speed motion pictures recorded the event. There was a small blisterlike separation observable in one frame, followed by rapid growth of an apparent disbond and explosive separation of the inner skin-to-core bond, accompanied by extensive fracture of the inner skin (see Figure 3; from Ref. 2).

Investigation indicated that the failure initiated in an area in which there had been a weak bond, i.e., there was no imprint from the core on the adhesive film. However, no discrepancies had been noted (i.e., no voids observed) in this particular area, based on numerous sonic ("tap") tests. (Many other areas had been found defective and were repaired by injecting a liquid epoxy resin to fill the discrepant/debonded areas.) Various possible causes were postulated for the "weak-bond" area:

- a. Contamination of core or adhesive film surfaces
- b. Inadequate flow of adhesive during cure
- c. Cure pressure and/or temperature too low (affects adhesive flow and contact between core cell walls and skins)
- d. Poor contact between mating surfaces
 - 1. Poor fit
 - 2. Cure pressure too low

Particularly noteworthy, the "tap" inspection had failed to detect the discrepancies in both AC-58 and AC-59 fairing failures; and both fairings had similar designs processing, including nonvented honeycomb construction.

In the recovery effort, it was decided to apply additional cork insulation on the exterior to reduce the glueline temperature and to conduct an overpressure proof test of the AC-68 payload fairing intended for flight. It was noted also that there had been improvements in the materials and processes for fairings produced after AC-59, i.e., for AC-60 and beyond. A thicker adhesive film was introduced, and more attention was paid to processing details and controls. Also the inner skin was increased from three to four plies.

The augmented overpressure, ambient-temperature, proof test was implemented successfully for the AC-68 payload fairing. The maximum expected pressure during flight was calculated to be 16.1 psi, allowing for pressure rise due to heating to 155°F at the bondline. Allowance also was made for bond strength reduction (8%) at elevated temperature (155°F), 1.3 psi; water partial pressure saturated at 155°F, 0.8 psi; and instrumentation error (5%), 0.9 psi. Accordingly, the overpressure proof test was conducted at ambient room temperature by pressurizing internally to 19.1 + 0.5/-0.0 psi using GN₂. (Subsequently the AC-68 payload fairing, with additional cork insulation on the exterior, was used successfully to help launch the FLTSATCOM F-8 satellite into orbit.)

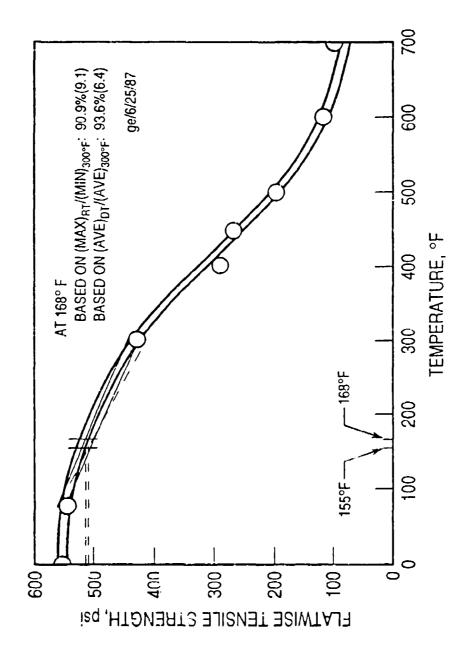
Figure 4. Typical Relationship Between Skin-to-Core Bond Strength and Test Temperatures

For applications which involve elevated-temperature exposure, the reduction in bond strength is an important factor to be considered. For example, see Figure 4 which was used in establishing the overpressure allowances for the AC-68 payload fairing. Inasmuch as the overpressure proof test was conducted at ambient room temperature, the internal pressure applied was increased by a finite amount to accommodate the reduction in bond strength that would be expected at the maximum temperature during ascent.
